Manhole Inspection Summary

Manhole # S25AA1015MH

Insp Date: **1/29/07 1:04 PM**

Location Address: **1300 36TH ST**

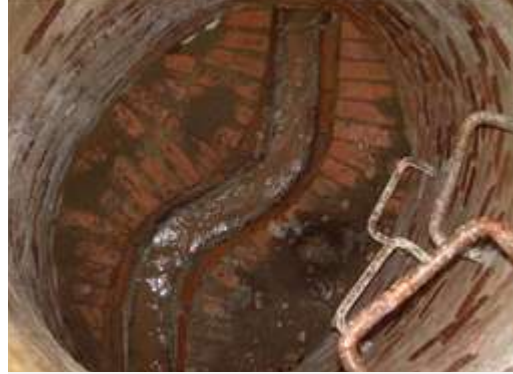
Top View

☐ Parged ☒ **Debris** (not Condition related)

Count: **5** Missing: **0** ☒ **Corroded**

Bench debris. Corroded steps.

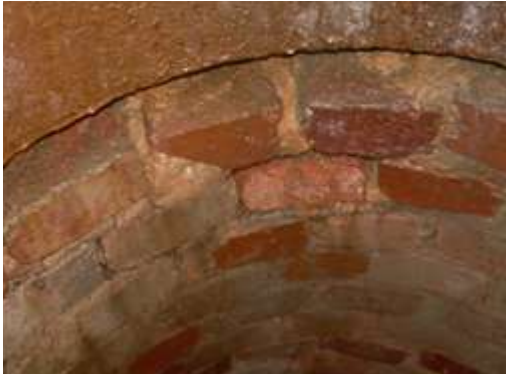
Defect

Condition: ☐ Sound ☐ Cracked ☒ **Leaks**

Condition: ☐ Sound ☐ Cracked ☐ Root Intrusion ☐ Loose Brick ☒ **Deteriorated**

Infiltration: ☐ None ☒ **Joint** ☐ Cracks ☒ **Mortar** ☐ Roots ☐ Wall

Frame leaks. Adjustment deterioration and infiltration.

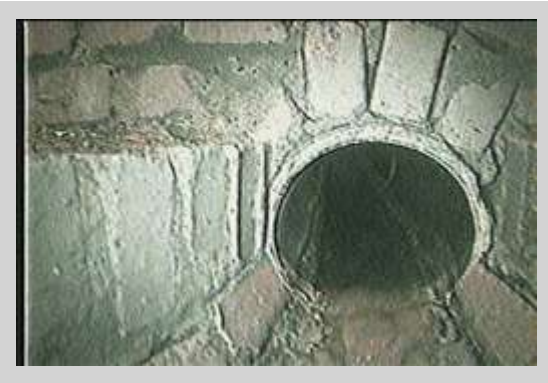
8 in. Circular Gravity Sewer Pipe Out @ 12 O'Clock

Condition: ☐ Sound ☐ Cracked ☐ Root Intrusion ☒ **Deteriorated** ☐ Leaks ☐ Debris

Channel deterioration.

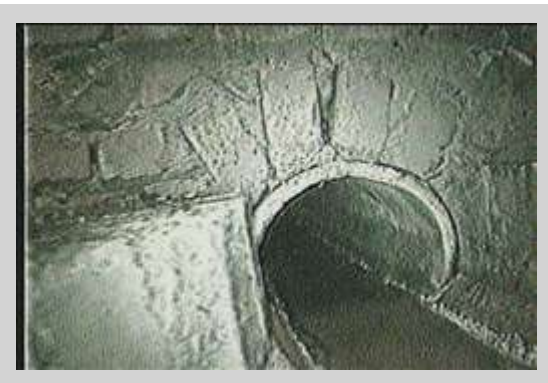
8 in. Circular Gravity Sewer Pipe In @ 6 O'Clock

Deposits: ☐ None ☐ Mud ☐ Sludge ☐ Debris ☒ Grease

Silt Depth: **0** (in.) Deposits Extent: **Light**
